## **7.2 COMMUNICATIONS**

## 7.5 GUIDANCE, NAVIGATION, AND CONTROL

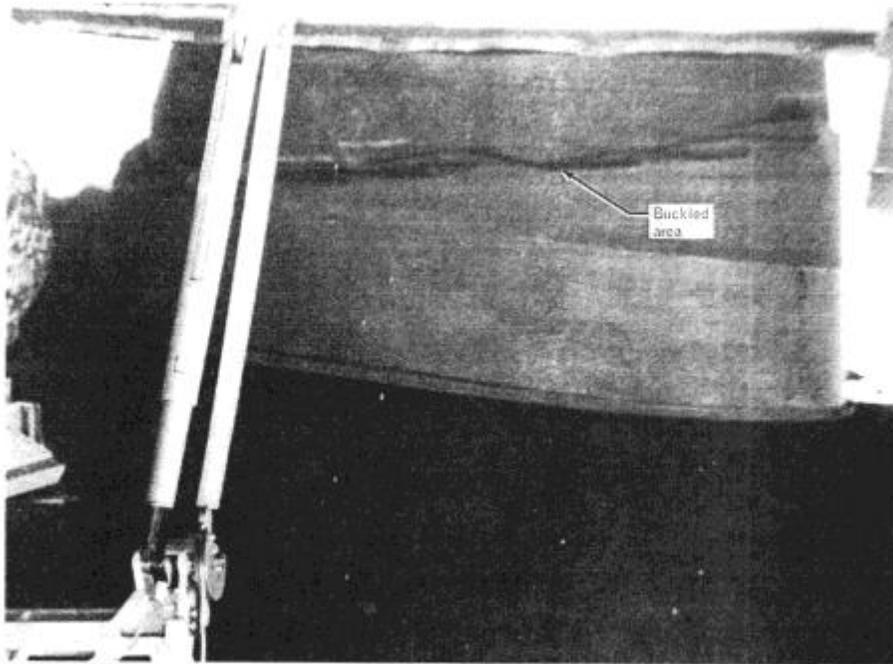
Figure 7-1.- Buckling of descent engine skirt.

The crew reported that there was a gap between the exit plane of the skirt and the lunar surface, indicating that buckling was probably caused by a buildup of pressure inside the nozzle due to proximity to the lunar surface, and not due entirely to contact of the nozzle skirt with the lunar surface. The crew also reported that the buckling seemed to be uniform around the skirt periphery and that the exit plane height above the surface was uniform.

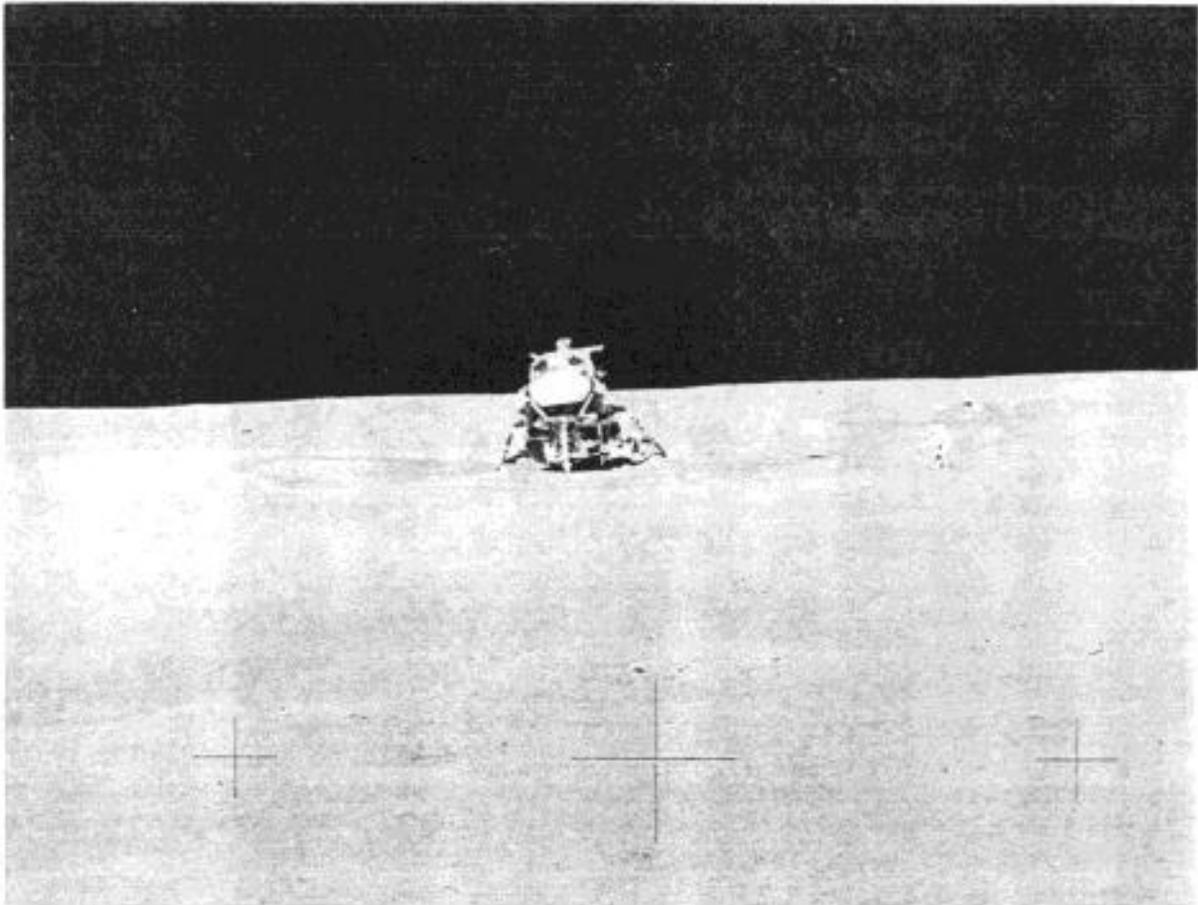
The vehicle contact velocity and attitude data at touchdown show that the landing was very stable in spite of the relatively high lunar surface slope at the landing point. The plus-Z and plus-Y footpads contacted the lunar surface nearly simultaneously, providing a nose-up pitch rate of 17 deg/sec and a roll rate to the left of 15 deg/sec. Final spacecraft settling occurred 1.8 seconds later. The vehicle at-rest attitude, as determined from the gimbal angles, was 6.9 degrees pitch up and 8.6 degrees roll to the left, resulting in a vehicle tilt angle on the lunar surface of approximately 11 degrees from the horizontal (**Fig. 7-2**).

Figure 7-2.- Attitude of lunar module on lunar surface.

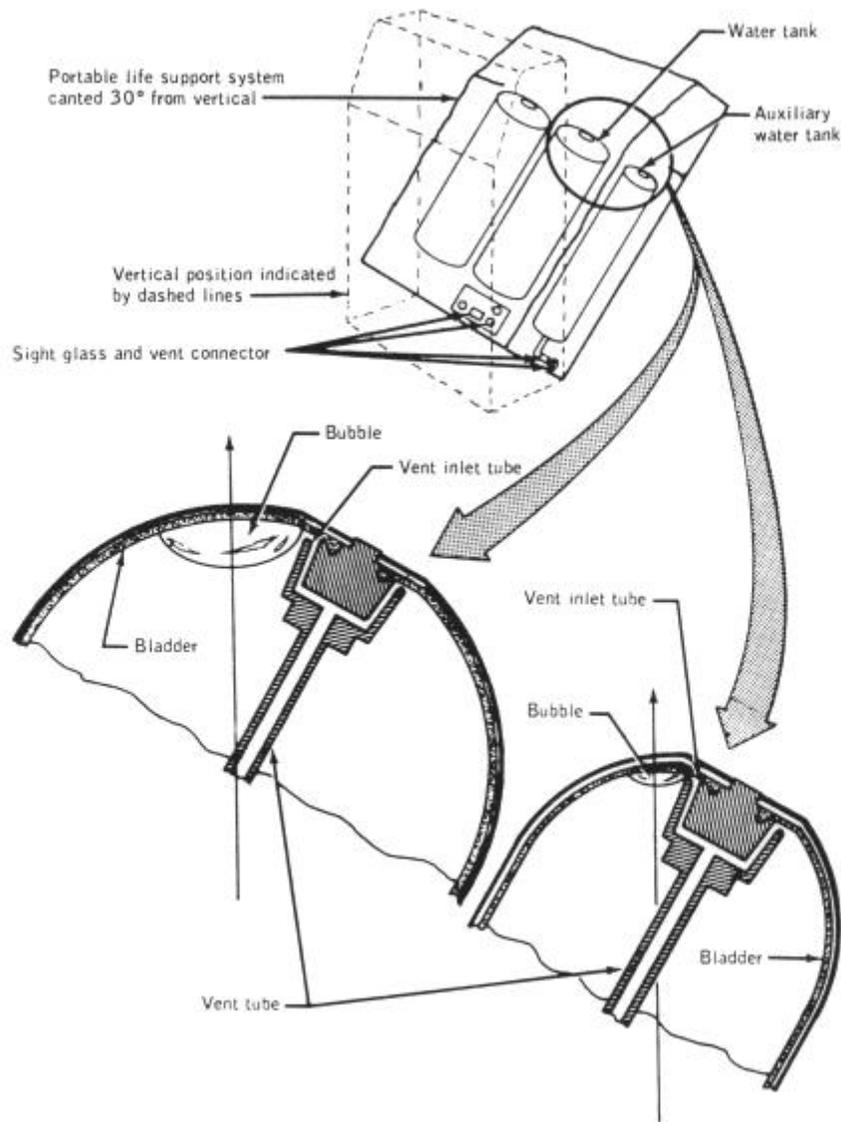
Figure 8-1.- Effect of tilt during water recharge

Subsequent to recharging the portable life support systems after the first extravehicular activity, the problem associated with the Lunar Module Pilot's water separator was found to have resulted from filling the portable life support system at a 30-degree tilt, and the unit was recharged thereafter while in the proper upright position.

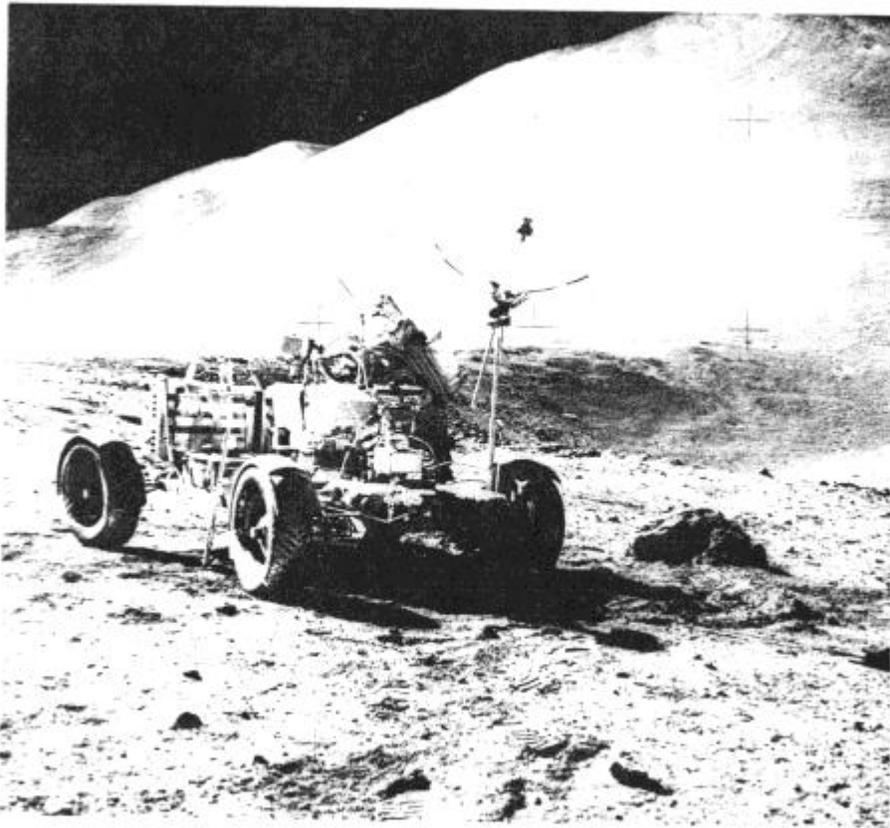
The lunar roving vehicle (**Fig. 8-2**) performed well during the mission. During the three lunar surface extravehicular activities, the vehicle traveled 27.9 kilometers (15.1 miles) during 3 hours and 8 minutes of driving at an average speed of 9.2 kilometers (4.97 miles) per hour. A total of approximately 52 ampere-hours was consumed. Navigation errors were within expected tolerances with small distance errors and no apparent gyro drift. The combined wander and wheel slip factor was within predicted limits.

The front-wheel steering was inoperative during the first extravehicular activity, but operated normally for the second and third extravehicular activities. Simultaneous front- and rear-wheel steering was found to be more sensitive than desired, and difficulties were experienced with the seat belts; but overall, the crew was very pleased with the vehicle's performance, particularly, the speed and hill-climbing capability.

Figure 8-2.- Lunar roving vehicle.
